Response to Suffolk County Council Framlingham Flood Investigation Storm Babet 2023

Framlingham Flood Resilience and Recovery Working Group

Part 2 Consolidated Recap of Framlingham Flooding Documentation

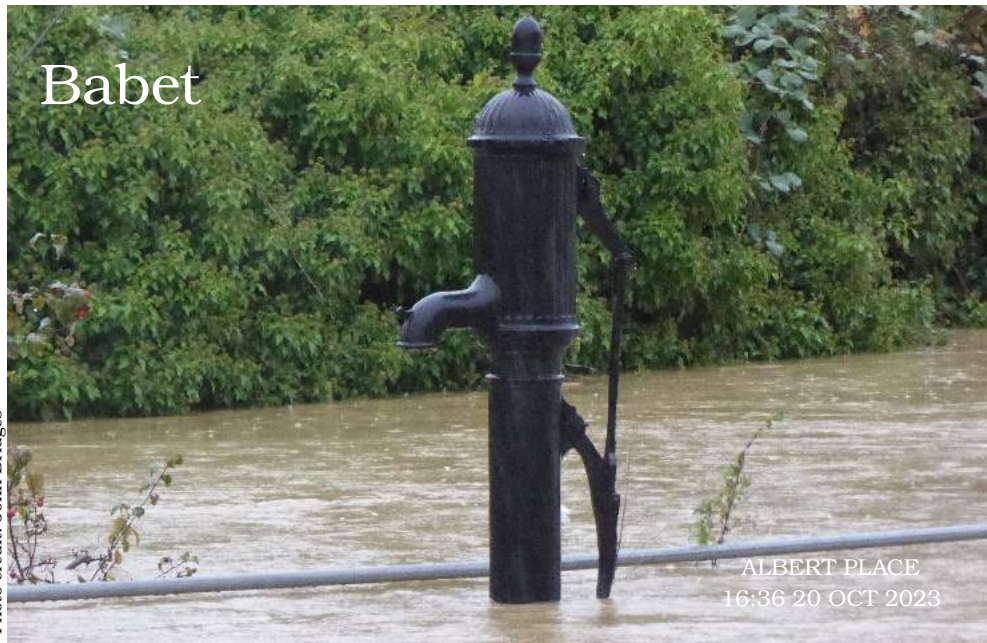
Fram's Flood History since 1850s

- 21 floods into properties, incl. 9 severe
 - 16 others with no mention of flooded properties
 - in one year 3 severe floods (1879)
 - Babet (2023) the deepest yet
- Long pauses
 - early 1950s to 2023
 - 1614 flood : "More than 2 centuries are said to have elapsed between that and the next (1853)" [Fram Weekly News, 1910]
- Reliable data? yes and no
 - multiple sources carefully searched, mostly newspaper reports & photo archives
 - severe max flood levels are based on measurements or hearsay of measurements
 - many thanks to John Bridges for his research and discussions (but, any errors or omissions are mine alone)

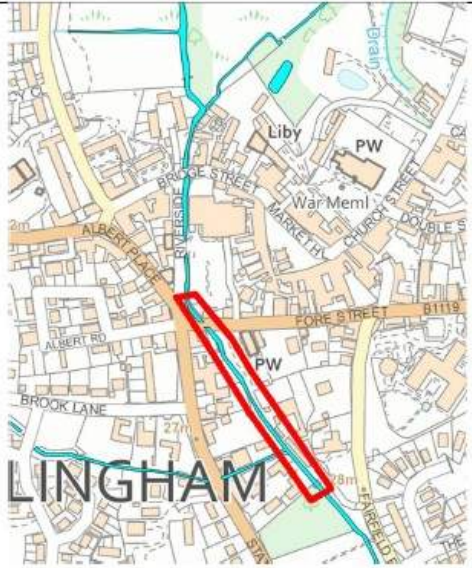
<p>B10.2 New (additional) Conveyance channel/culvert through the Town</p>	<p>More controlled conveyance of flow from the Mere to downstream of Framlingham</p>	<ul style="list-style-type: none"> • It would need to be very large, within the low areas and there is not enough room • Land ownership/permissions • Many properties on surface water route to River will not benefit • Would need to ensure no increase in flooding downstream where water would be received quicker. • Would need a detailed hydraulic model to assist with design and confirm resulting benefit • May still be flood event more extreme than any designed mitigation. • Funding?
	<p>B10.3 Try and keep flow within the River channel. Flow overspilled onto Riverside and</p>	<p>Temporary defences at the northern part of the Town to prevent the Station Road flow exiting the river so flow remains in the main channel and its floodplain</p>	<ul style="list-style-type: none"> • The River channel downstream of where diversion would be needed was also at capacity and suffering significant flooding. This may have been downstream of a key constriction area though. The channel capacity in this area to be reviewed:

B		Storm Babet	
	Station Road and formed a second channel

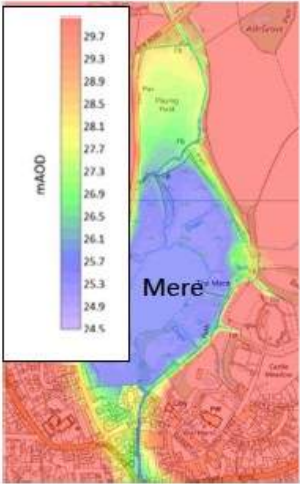
<ul style="list-style-type: none"> • May still be flood event more extreme than any designed mitigation • Funding • Land to be donated • Environmental considerations • Significant excavation required and would need depositing off site. • Hydraulic modelling required to demonstrate benefit. <div style="border: 1px solid black; padding: 5px; margin-top: 10px;"> <p>Info on scheme: Current field levels vary by over 2m from 26.2 to 28.3 mAOD. So, if dug down level to enable storage would need to have high embankments around the south and east of the field in particular to contain flow. Even if storage depth = 0.5 m, the volume that could be stored is c18,000 m³ A flow of 3 cum/sec would take 1.7 hours to fill this volume.</p> </div>

B	Storm Babet		
		<p>Existing ground levels:</p>

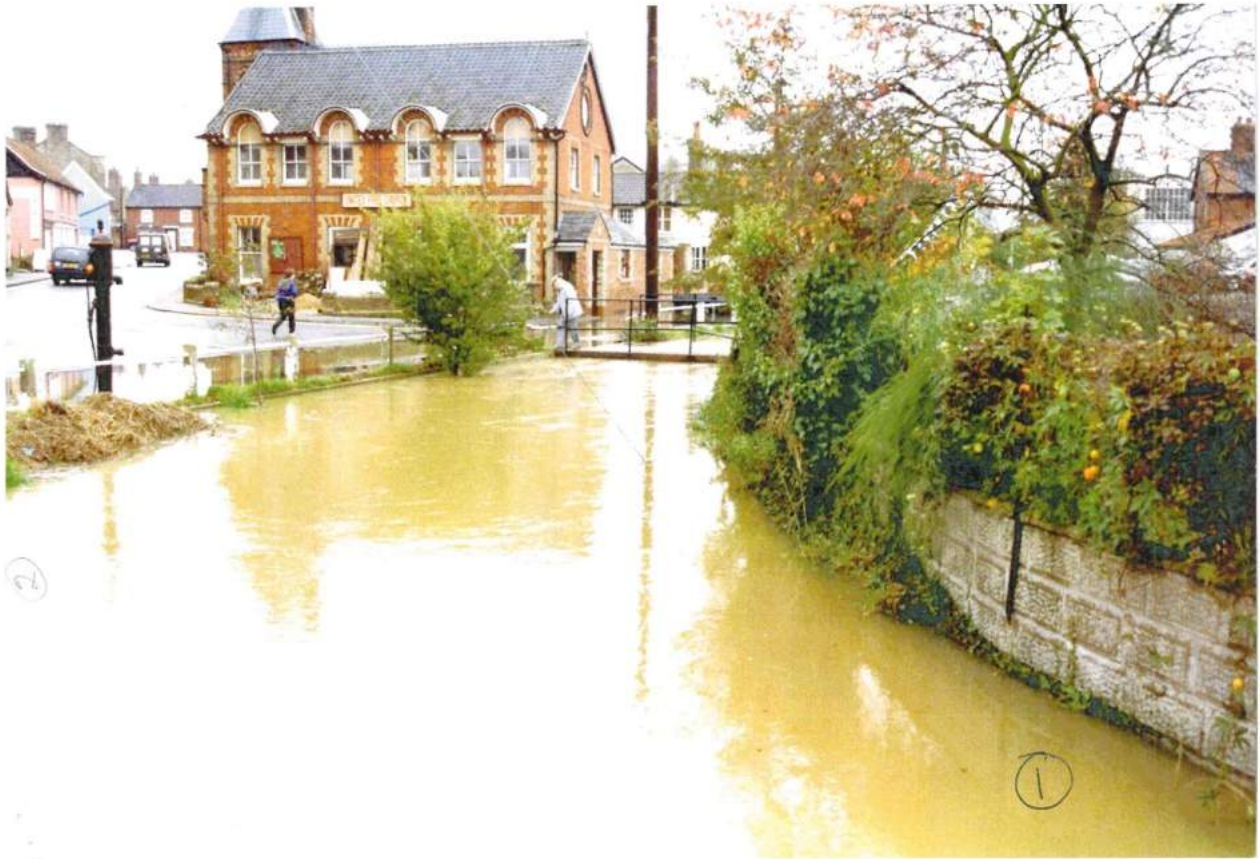
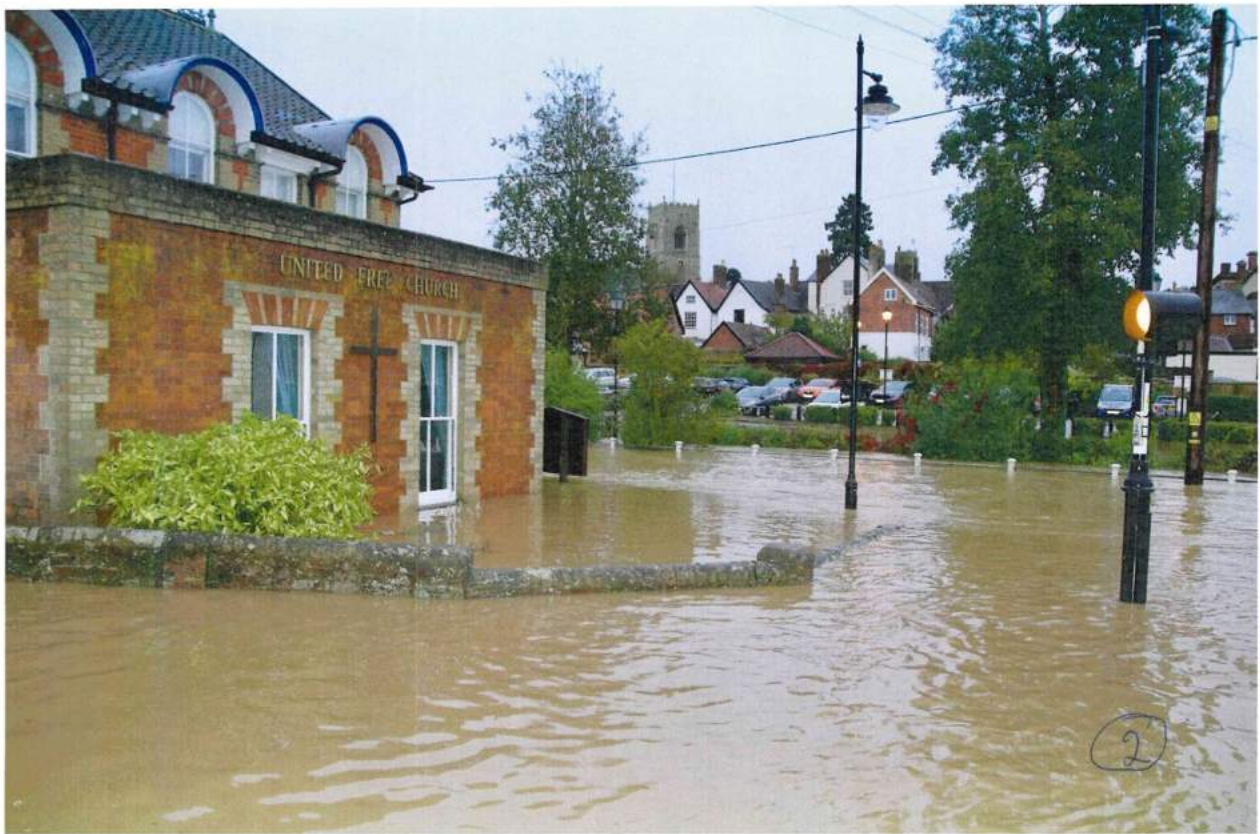
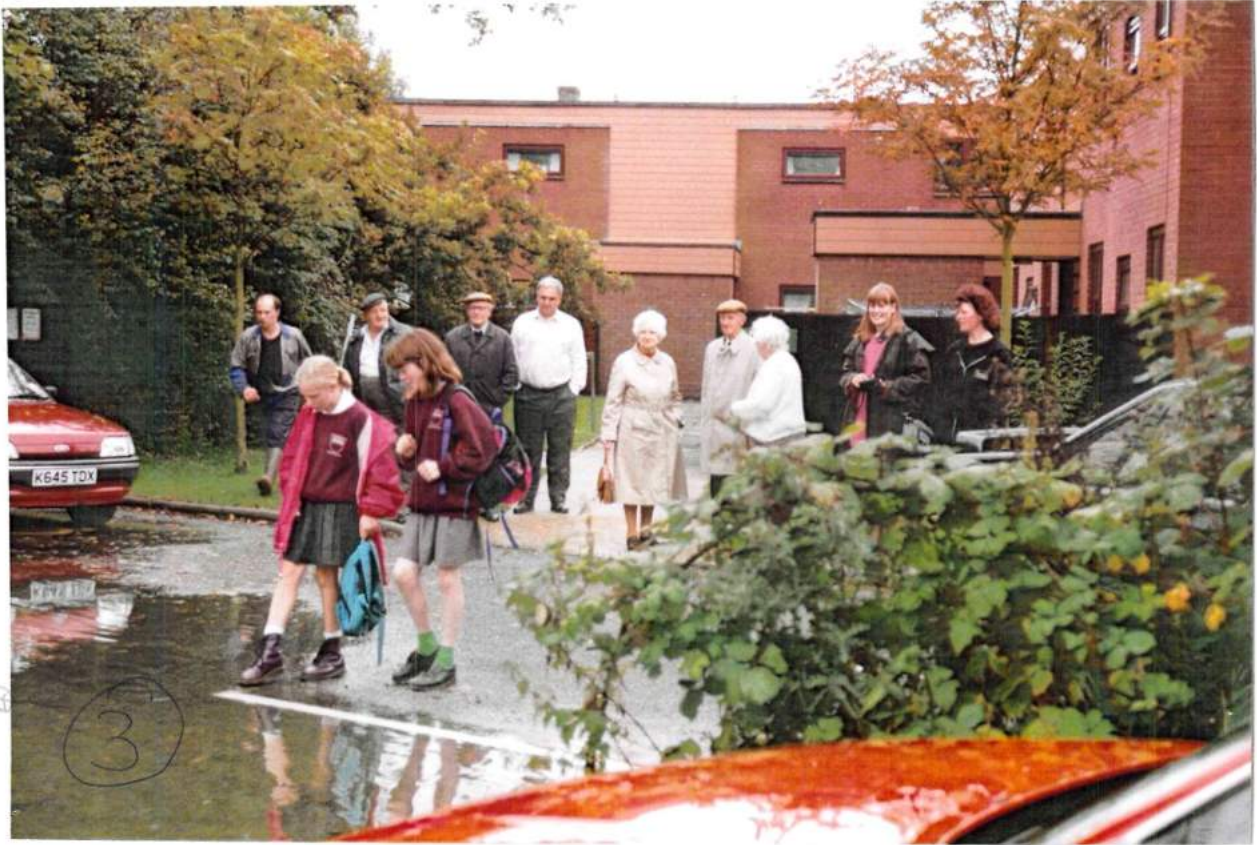
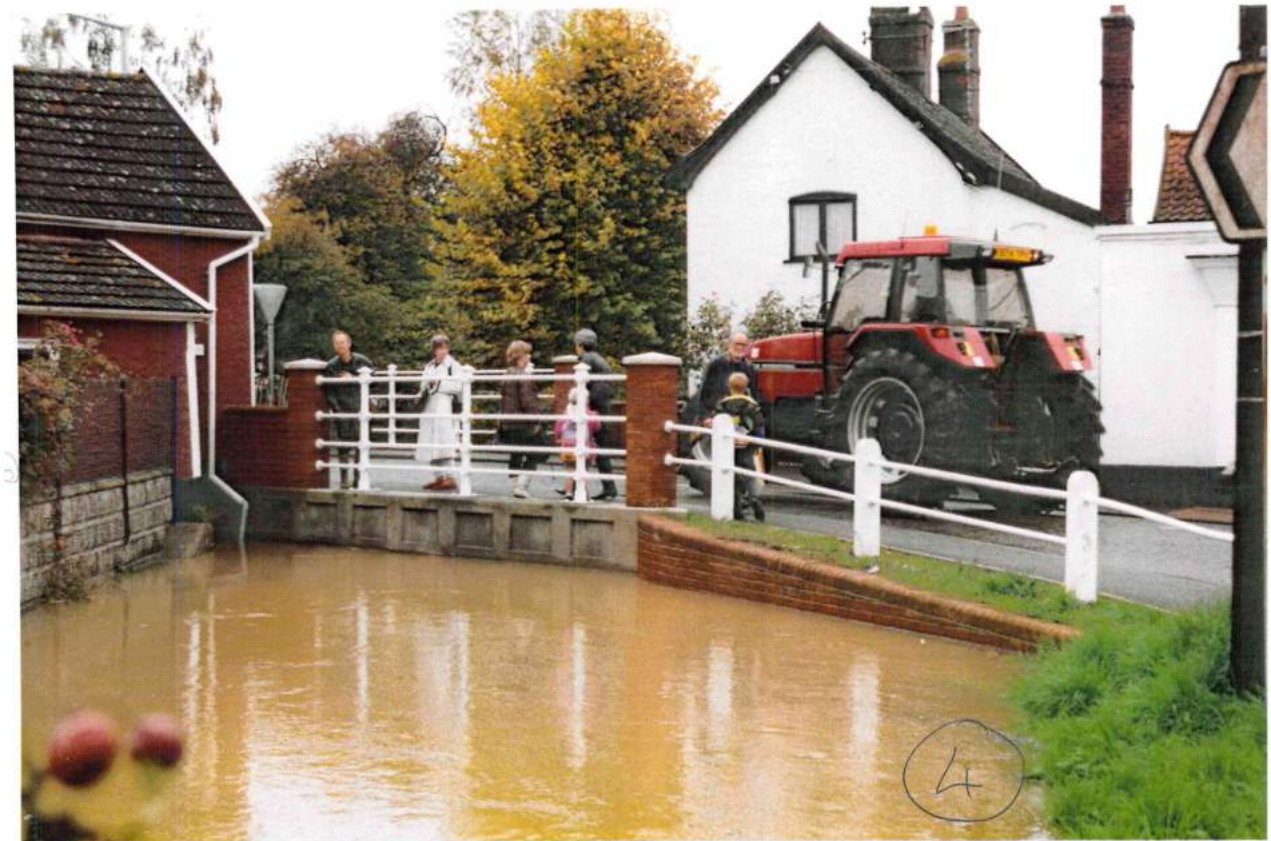
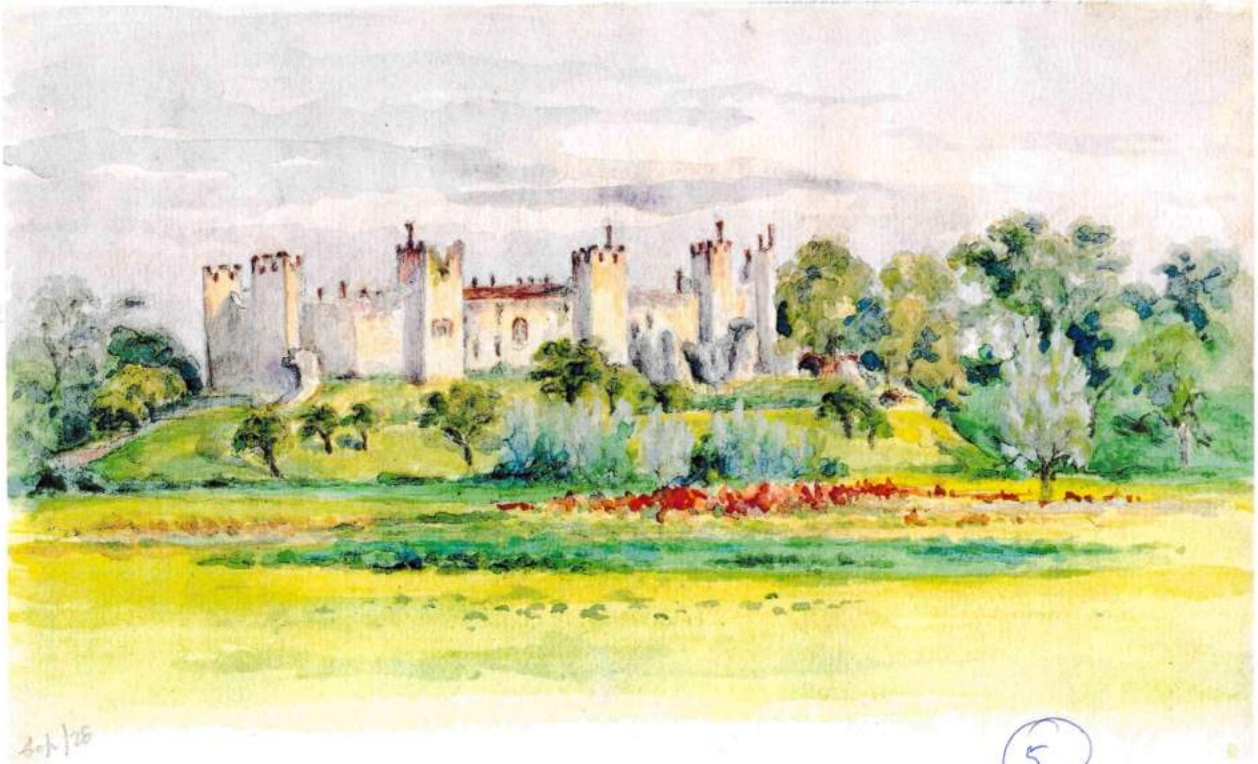
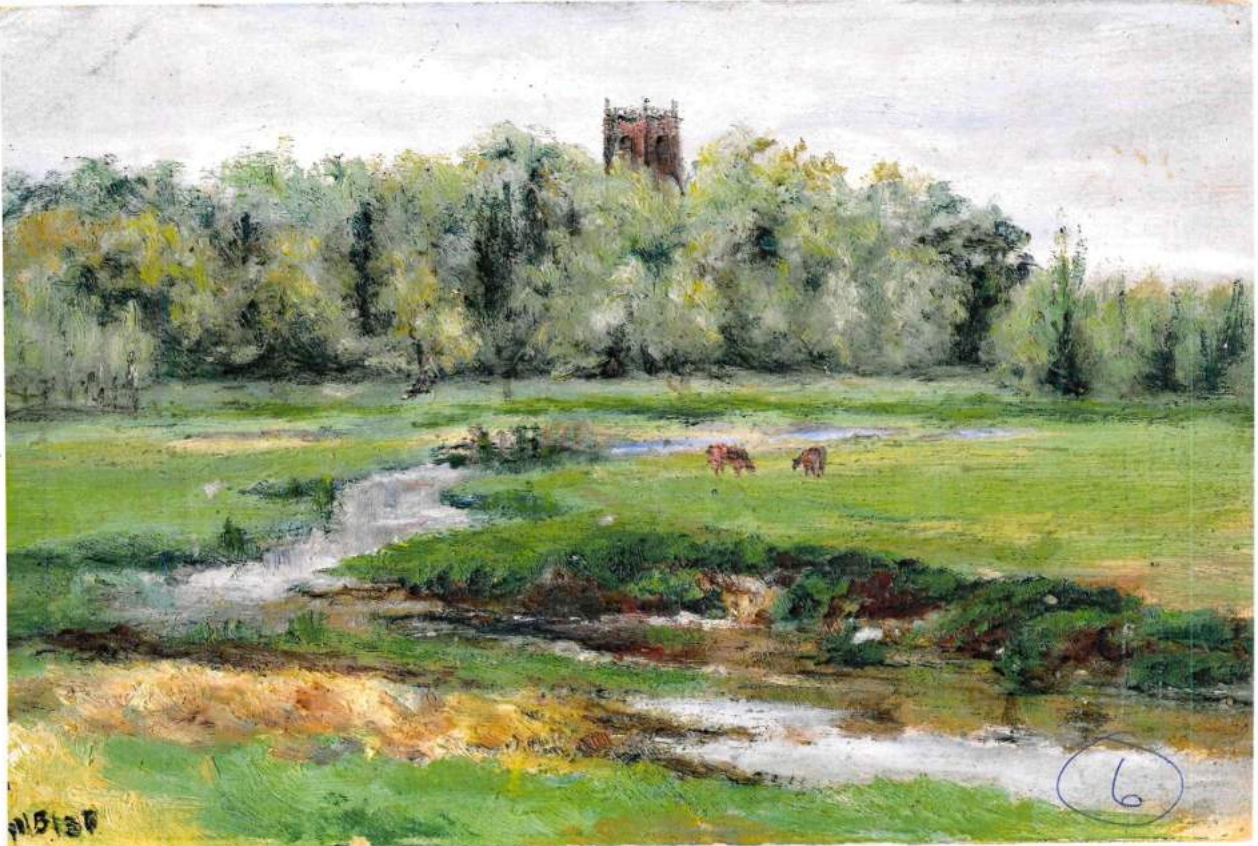
Photo Index

1. United Free Church 1994/5
2. United Free Church October 2023
3. Back of the Elms 1994/5
4. Fore St 1994/5
5. Painting by Channing Dowsing September 1928
6. Painting by Pop Haynes May 1937
7. Arable land holding water upstream. Note field has been drilled with OSR. 1994/5
8. Arable land in suitable condition to repel flooding 1994/5
9. Dredging 1994/5
10. Wash from large vehicles can negate the benefits of sandbags.

Up until this year, much winter wheat, barley and OSR have been traditionally sown in September. By mid-October many areas are green and very actively growing. In 2023 sowing was much delayed by the lack of moisture, so when it did rain crops were sown very rapidly. Large areas sown at the same time resulted in deep flooding (see Photos 8 and 9) in rural areas. The water simply could not get away quickly enough.

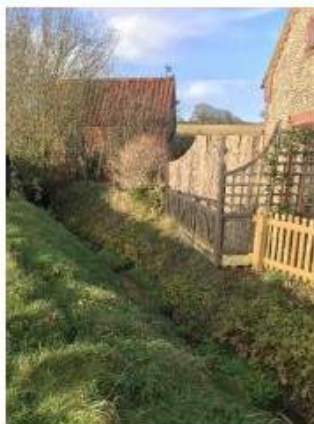
It is not always obvious if you are a Riparian Owner. The image to the right shows a watercourse next to a residential property. It is likely the centre of the watercourse (not the fence) forms the property's boundary. This means the landowners on each side of the ditch will own and be responsible for halfway across the watercourse.
